#### Building Standard Commission Review

Creekside Apartments

Address: 406 Deats Road, Dickinson Texas 77539

# Creekside Apartments 406 Deats Rd. Dickinson TX 77539

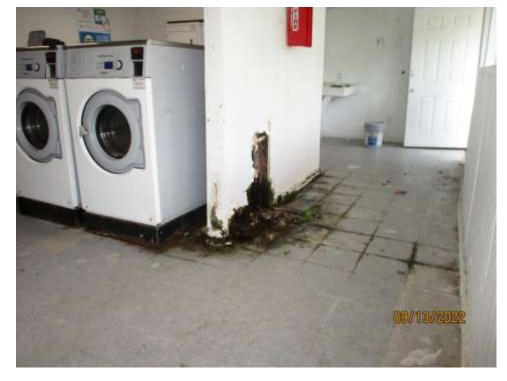
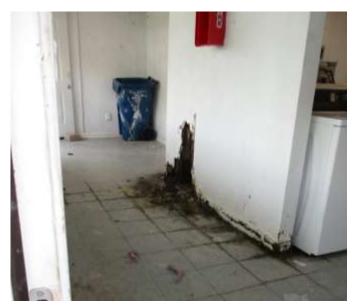
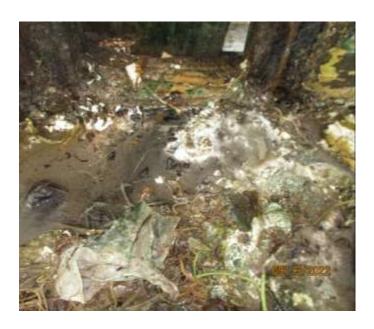
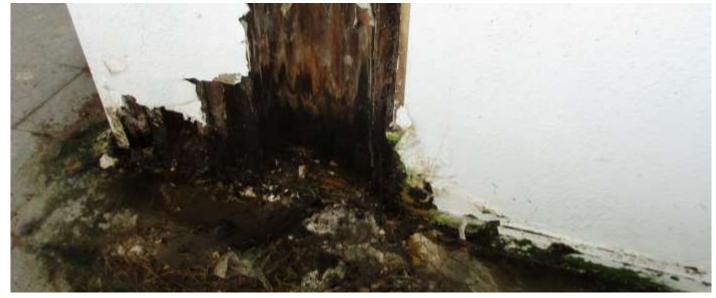
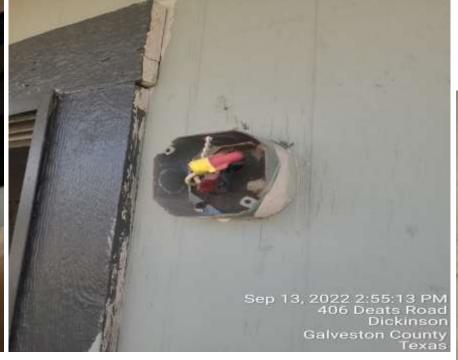
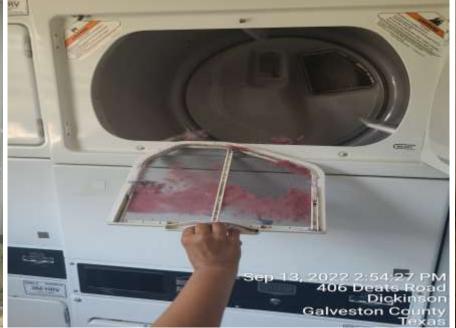
## Laundry Room 1

The exterior of the property and premises found lack of maintenance and was unclean and hazardous conditions were found; including accumulation of weeds, vegetation, junk, dead organic matter, debris, garbage, rat harborages, stagnant water, combustible materials, and similar materials which could constitute fire, health or safety hazards and could create a place for rodent harborage and infestation.

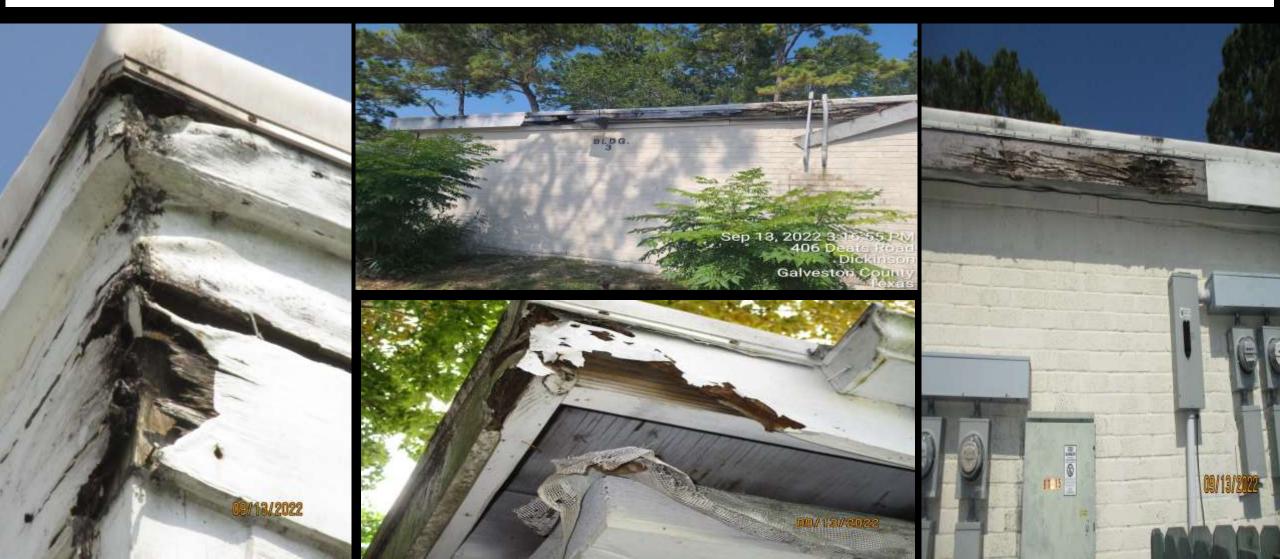
EXTERIOR STRUCTURE 304.7 Roofs and drainage. The roof and flashing shall be sound, tight and not have defects that admit rain. Roof drainage shall be adequate to prevent dampness or deterioration in the walls or interior portion of the structure. Roof drains, gutters and downspouts shall be maintained in good repair and free from obstructions. Roof water shall not be discharged in a manner that creates a public nuisance.

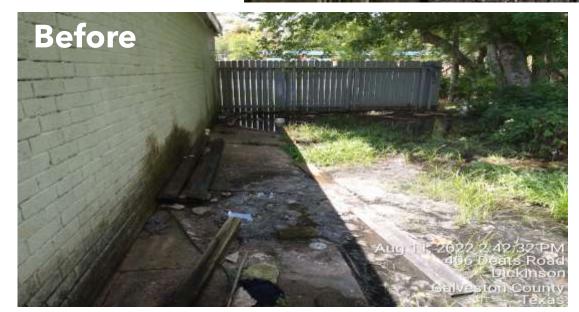
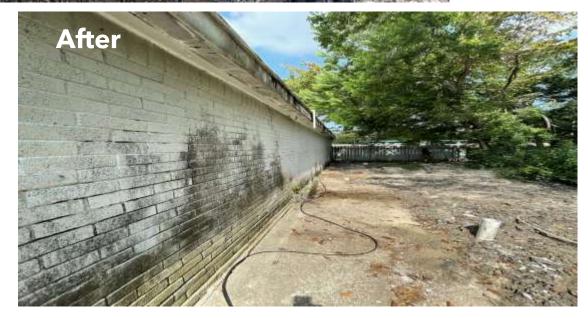
Building 16

During the inspections we observed sewage wastewater on the ground, sewage can be hazardous to the environment, the ground water and other bodies of water, as well as contain bacteria, fungus, viruses, and harmful diseases to people. We found areas of overflowing sewage in at least 4 locations around the property.

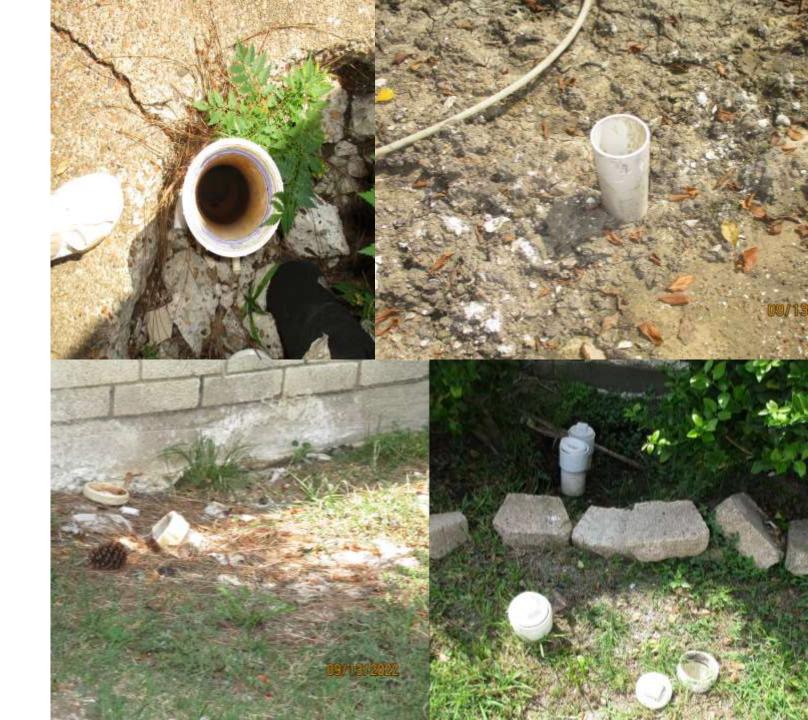
Open sewer cleanouts

were found throughout

the property, exposed

sewer pipe and raw

sewage found near

apartments 19, 9, 3, 4, 16

and at the office.

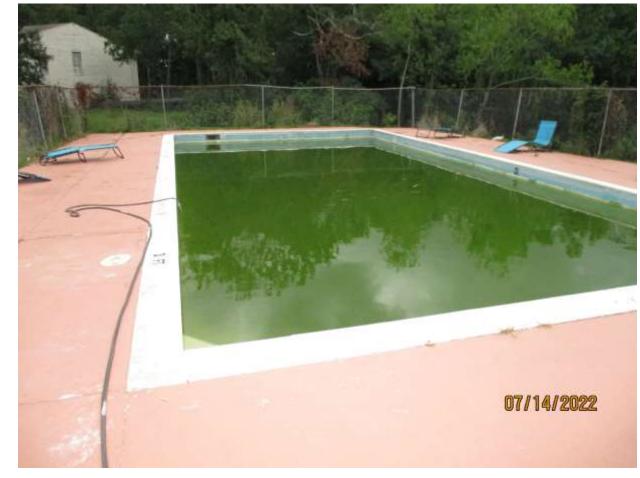
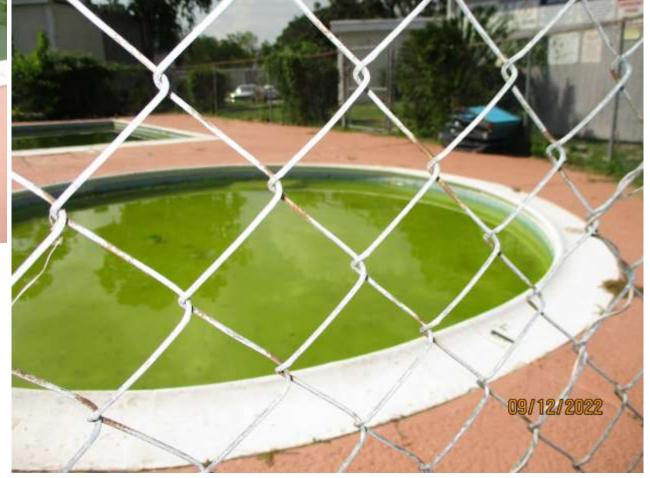
The following slides will demonstrate the observations of the inspectors who saw violations of Chapter 12 Article II Section 12-47 (c) stagnant water and Chapter 5 Article II Sec. 5-21 (8) 2018 International Property Maintenance Code Section 303 regarding: Swimming Pools, Hot Tubs & Spas The existing swimming pool were noted on the property. One pool appears to be covered with non-weather resistant lumber that was dislodged from its built foundation. The protective chain link fencing was inadequately locked and secured. Large accessible holes and loose fencing allows the area to be accessible. The interior perimeter was grossly overgrown with high grass and weeds. Visual inspection could not determine whether there was water in the pool. The second pool located adjacent to office was filled with green, stagnant water creating a life safety concern and insect infestation health hazard. Both pools appear to have been in a long-term condition of disrepair.

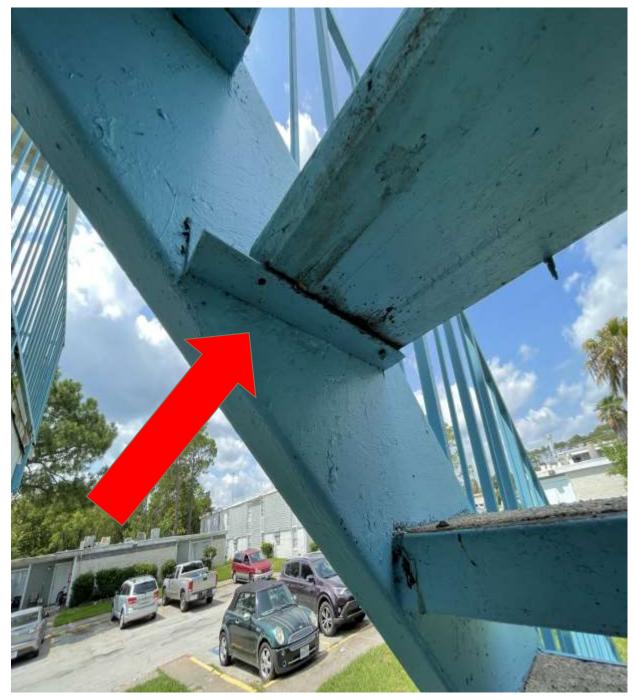
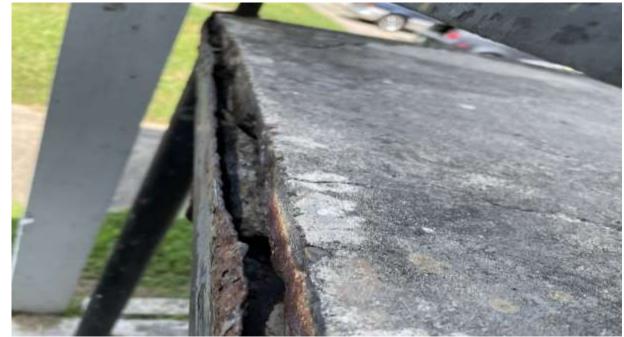
Chapter 5 section 5-04 (b) (4) Structural deformities.

A building or structure which has been built and constructed in such a manner as to be hazardous in that the construction of the building or structure is of such a nature that it has placed the same in jeopardy of collapse or that the building or structure will not reasonably withstand customary and ordinary exposure to the elements; a building or structure which, because of the deficiency of its materials, methods or means of construction, including the foundation, structural elements, wiring or apparatus, plumbing and fixtures, entrances or exits, renders the building or structure unsafe and dangerous.

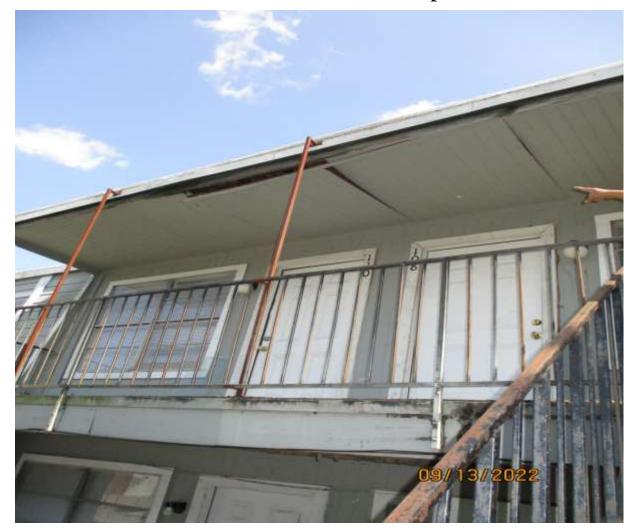
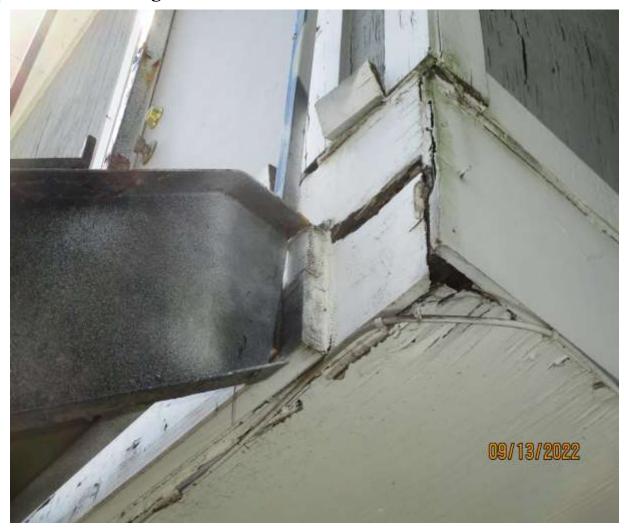
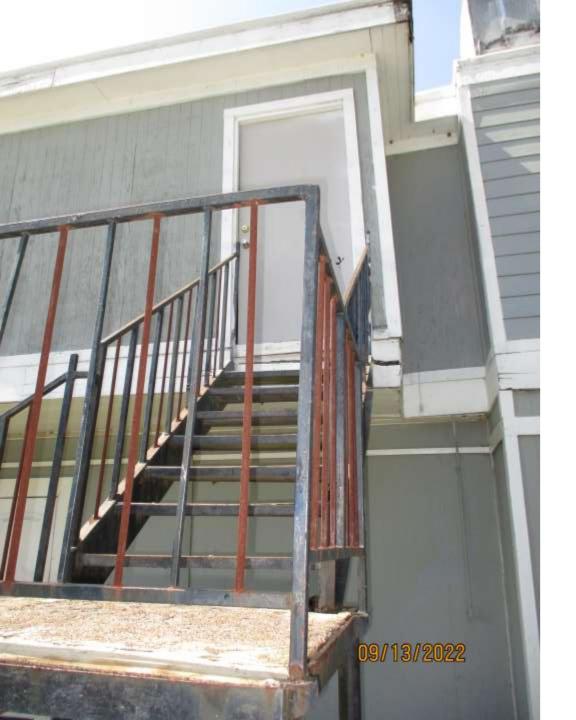
108.1.5 Dangerous structure or premises. For the purpose of this code, any structure or premises that has any or all of the conditions or defects described as follows shall be considered to be dangerous: 1. Any door, aisle, passageway, stairway, exit or other means of egress that does not conform to the approved building or fire code of the jurisdiction as related to the requirements for existing buildings. 2. The walking surface of any aisle, passageway, stairway, exit or other means of egress is so warped, worn loose, torn or otherwise unsafe as to not provide safe and adequate means of egress.

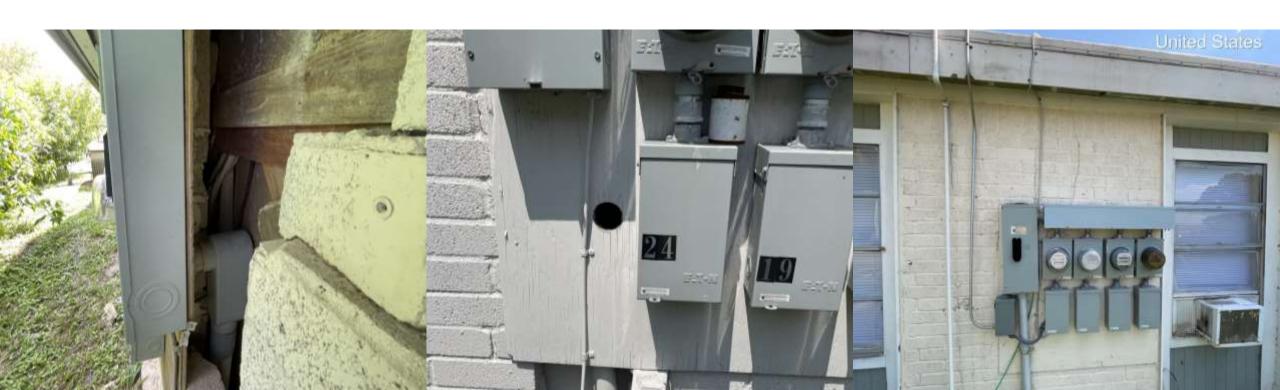
FINDINGS. Electrical service equipment appears to be anchored to failing nonstructural building components. Large areas of building materials (brick) are missing where the electrical equipment is mounted on many units leaving the interior of the structure open to environmental elements and rodent infestation. Obvious water intrusion was noted. In other areas, equipment has been mounted to bare lumber, and entire groups of service equipment are dislodging from their mounted services. Open wiring conductors were noted throughout exterior areas of the complex. Poorly mounted light fixtures were dislodging from their anchored surfaces and becoming fall and electrical hazards Improper use of electrical conductor material was noted throughout the complex. Use of interior conductors has been used on exterior of structure. Conductors appear to be MC cable and UF cable. Noted throughout the complex structures were dislodging rain gutters, dislodging facia boards, loose siding bricks, waterlogged siding and exposed interior construction components including but not limited to exposed insulation, exposed vapor barriers, exposed drywall, exposed plumbing and electrical.

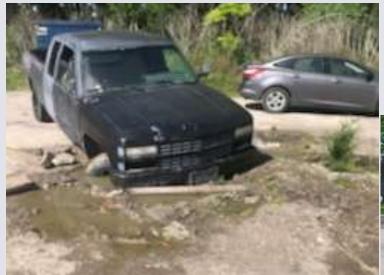
\*Improper maintenance of fire apparatus access road. Large potholes, crumbling asphalt, and deep ruts were observed to fire apparatus access roads throughout the complex.

\*Improper maintenance of fire lane markings and parking striping.

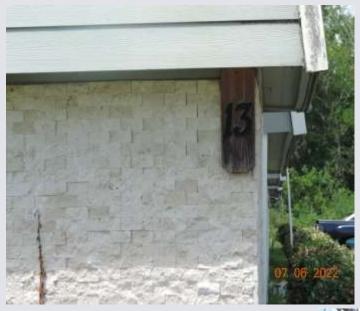
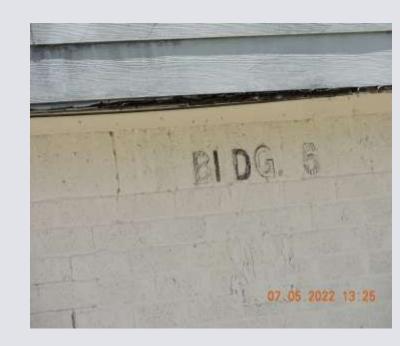
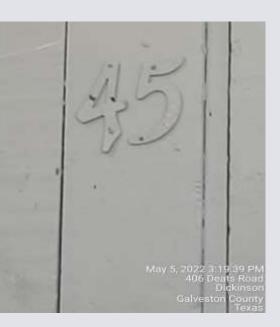
VIOLATION -Improper address identification.

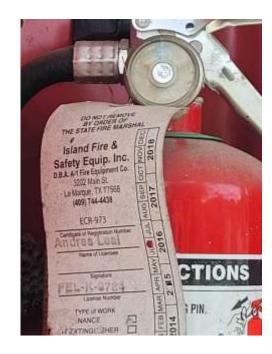
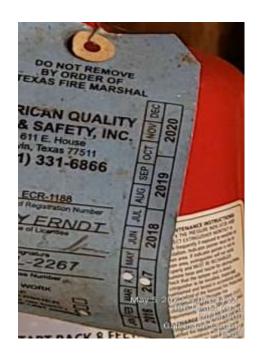
#### **VIOLATIONS**

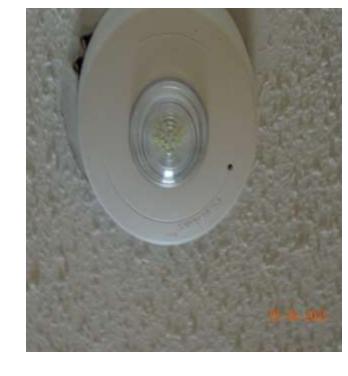
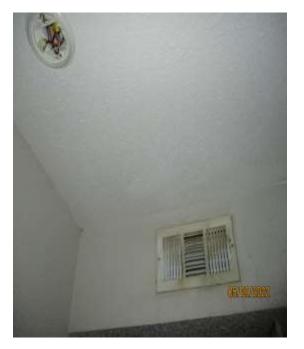
\*Smoke alarms improperly installed; smoke alarms not interconnected where required

\*No smoke alarm where required

\* Improper placement and instillation of smoke alarms

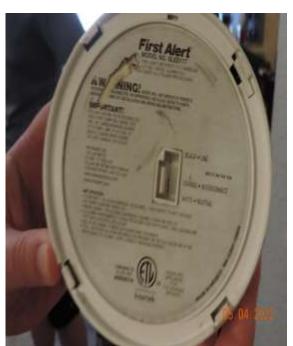
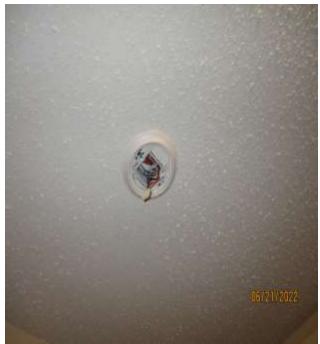
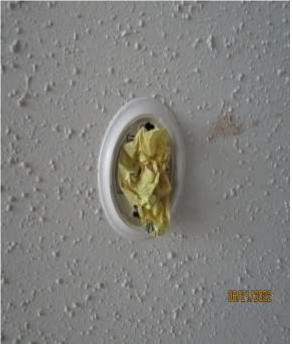
#### **VIOLATIONS**

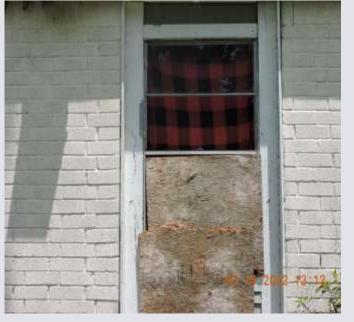
\*Improper maintenance of emergency escape opening

\*Obstruction of egress

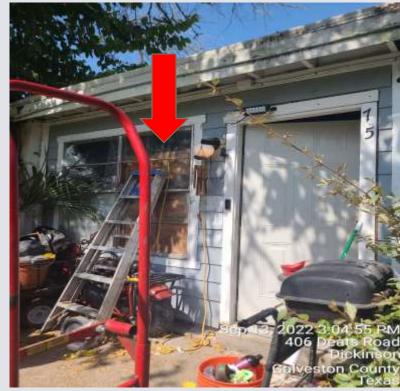
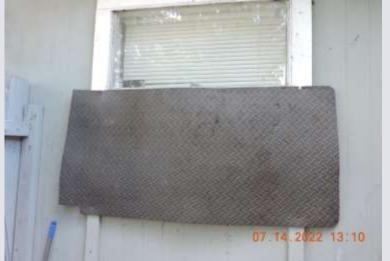
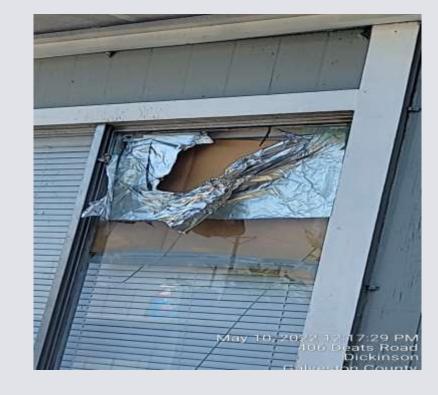
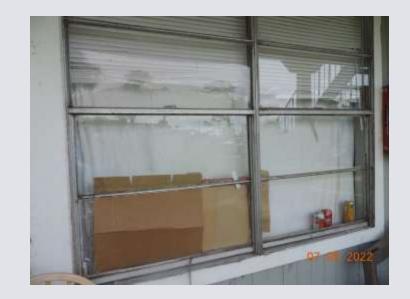
#### VIOLATION

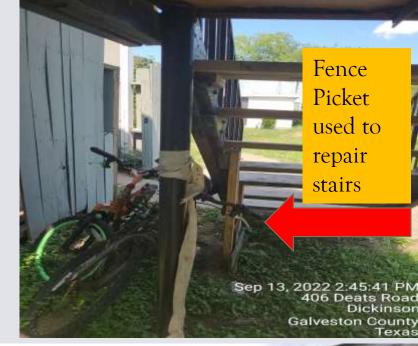
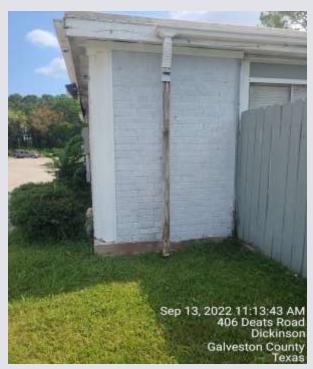
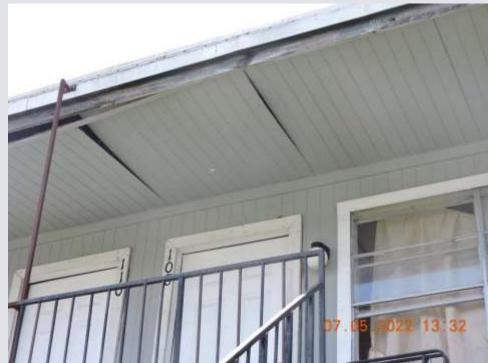
## VIOLATION- Observation of structural hazards 2018 IFC, Chapter 1, Section[A]110.1.2 Structural hazards.

Where an apparent structural hazard is caused by the faulty installation, operation or malfunction of any of the items or devices governed by this code, the fire code official shall immediately notify the building code official in accordance with Section 110.1.

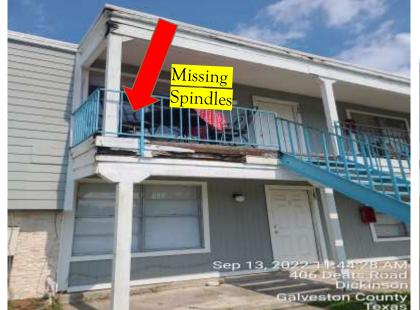
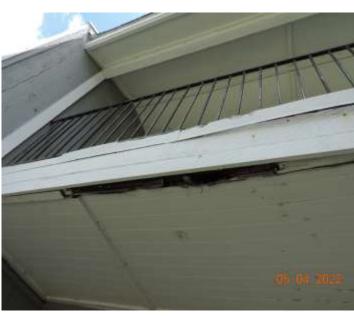
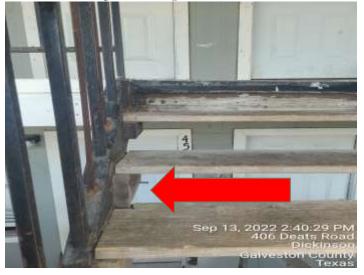
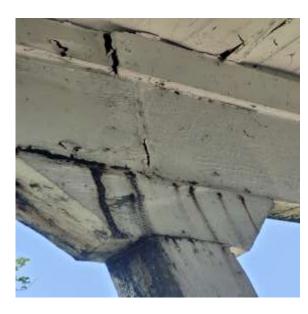
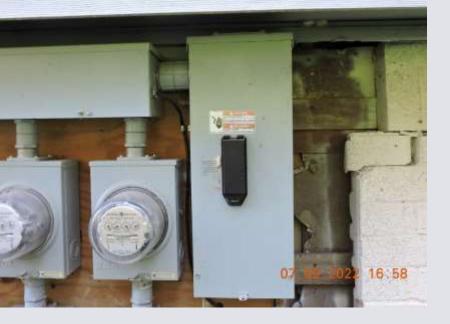
### 2018 IFC, Chapter 1, Section 111 [A]111.1.1 Unsafe conditions.

Unsafe conditions were observed throughout the property including all structures and buildings on the property.

Structures or existing equipment have become unsafe or deficient due to: Inadequate means of egress, Penetrations of fire-resistive construction that constitute a fire hazard, leaking sewage, and uncapped washouts were observed in numerous areas throughout the property rendering conditions that are dangerous to human life and the public welfare, no certificate of occupancy, illegal or improper occupancy, and Inadequate maintenance of buildings,

mechanical systems, electrical components, and plumbing.

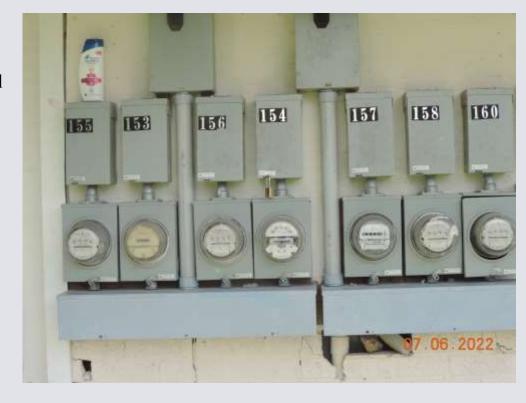
#### **VIOLATIONS**

\*Unsafe Conditions Continued

\*Penetrations in fire-resistance-rated construction.

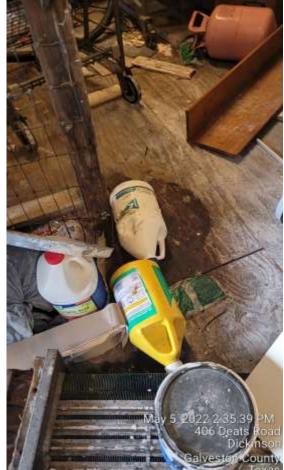
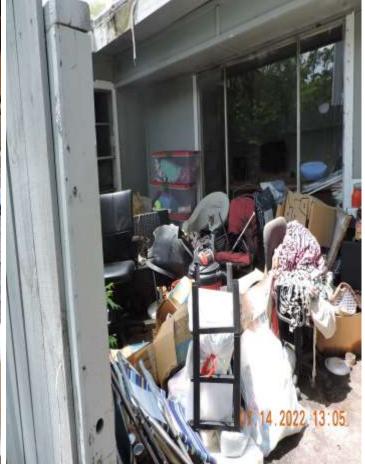
VIOLATION- Waste accumulation prohibited.

Improper storage of combustible rubbish 304.2 Storage.

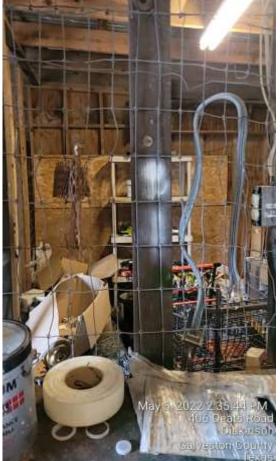
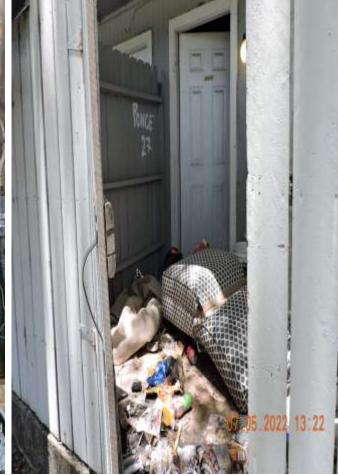
Storage of combustible rubbish shall not produce conditions that will create a nuisance or a hazard to the public health, safety, or welfare.

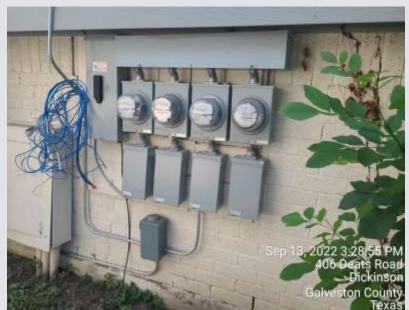
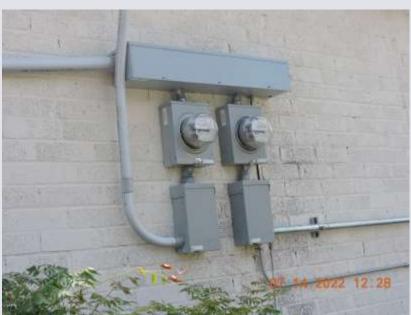
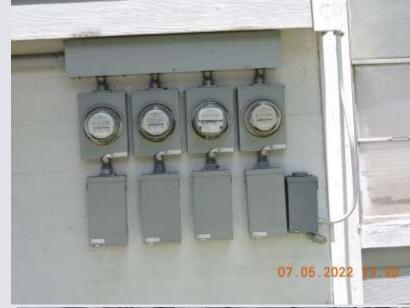
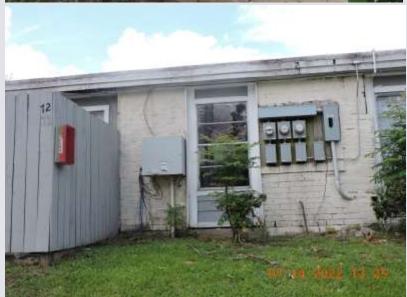
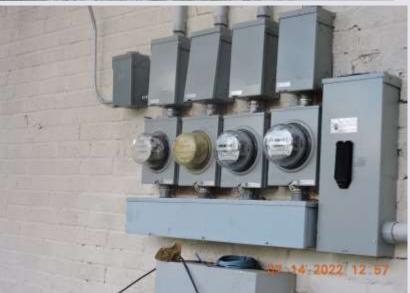
Electrical meters are required to be labeled identifying the service disconnect for each apartment.

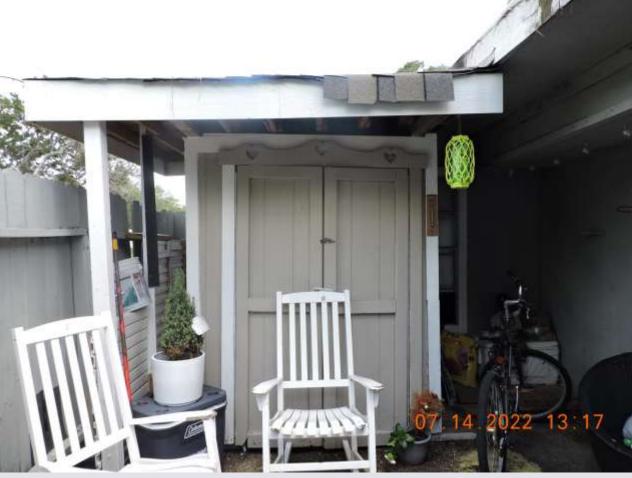
#### VIOLATION

\*Unpermitted Structure Structure erected without approved building permit or inspection.

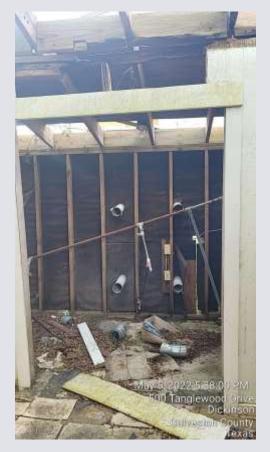
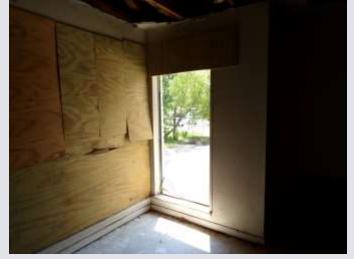
#### **VIOLATION-**

Observed vacant structures that are not secured against unauthorized entry as required.

2018 IFC Chapter 3, Section 311 for this reason buildings A, B, C, D, and E shall be deemed unsafe.
